**U.S. DEPARTMENT OF DEFENSE  
Environmental Security Technology Certification  
Program (ESTCP)**

**Final Report**

**Validation of HVOF Thermal Spray Coatings  
as a Replacement for Hard Chrome Plating  
on Hydraulic/Pneumatic Actuators**

**Project WP-0038**

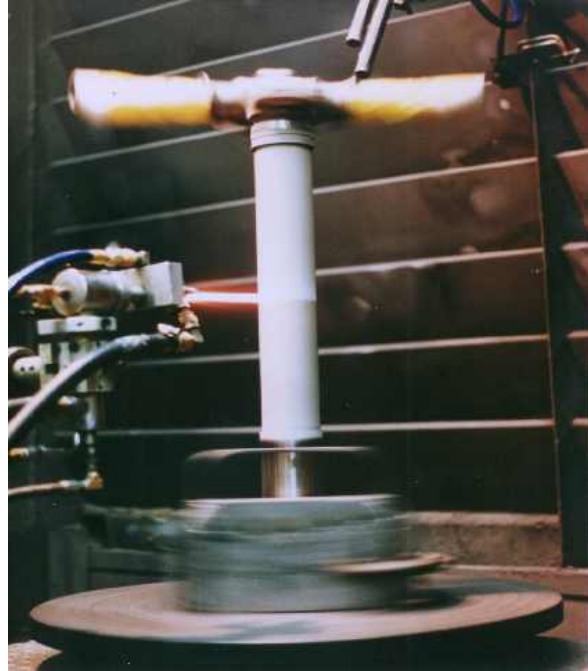
**Installation and Operation:** The HVOF gun can be hand-held and used in an open-fronted booth. However, the supersonic gas stream is extremely loud and requires that the operator use very good ear protection. For this reason the unit is usually installed on a six-axis robot arm in a sound-proof booth, programmed and operated remotely. Most depots already use this type of booth for their existing plasma spray operations. Since the method is frequently used for cylindrical items, the most common arrangement is to rotate the component on a horizontal rotating table and move the gun up and down the axis. This is illustrated in Figure 2-2 which shows the HVOF spraying of a landing gear inner cylinder. A similar setup would be used for the spraying of hydraulic actuator piston rods.

**Figure 2-2 HVOF Spray of Landing Gear Inner Cylinder**

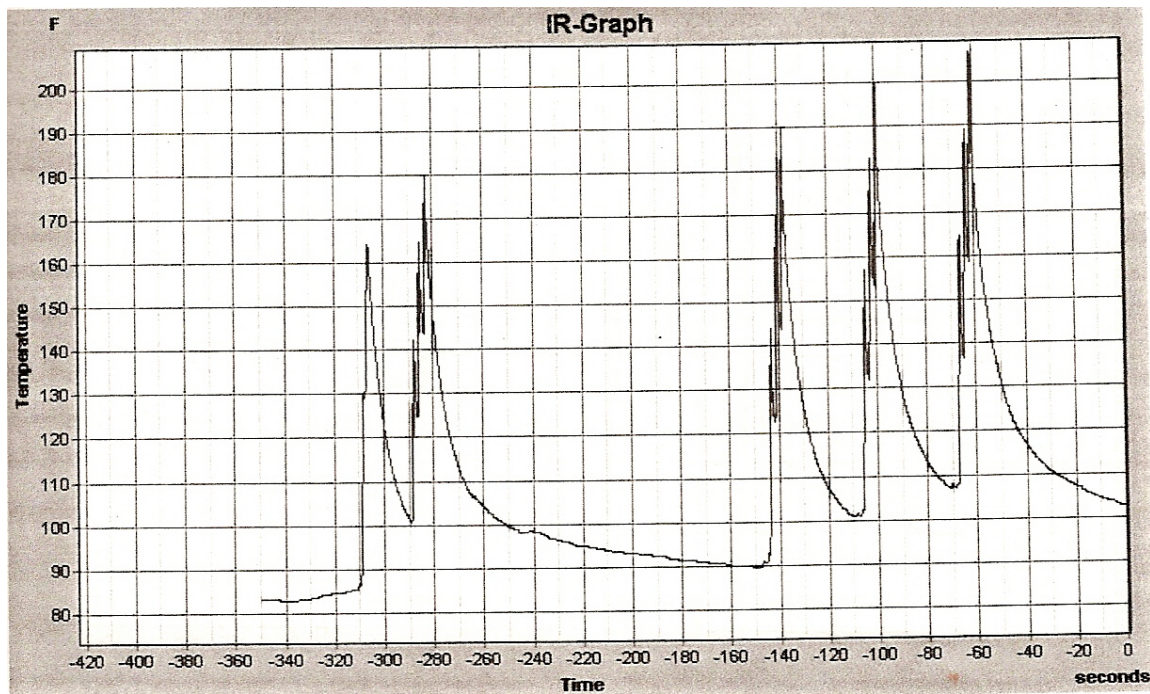
The surface temperature of the specimens was measured during HVOF coating deposition using an infrared pyrometer. Figure 3-2 shows a typical temperature chart obtained during the spraying, with the incursions occurring due to the spray plume moving on and off the specimen.

**Figure 3-2** Typical Temperature Chart for HVOF Spraying of Fatigue Specimens.

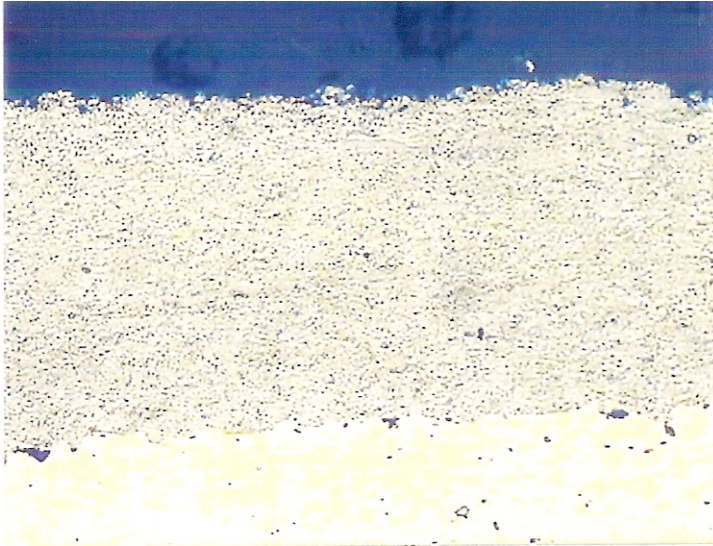
Prior to each HVOF run, Hitemco deposited the HVOF coatings onto test coupons and characterized the coatings to ensure they were meeting the required characteristics and properties. Cross-section metallography was used to measure the porosity and amount of oxides in the coatings. Figure 3-3, Figure 3-4 and Figure 3-5 show typical cross-section micrographs of the WC/CoCr, Cr<sub>3</sub>C<sub>2</sub>/NiCr and T-400 coatings, respectively.

**Figure 3-3 Cross-section Micrograph of Typical HVOF WC/CoCr Coating**

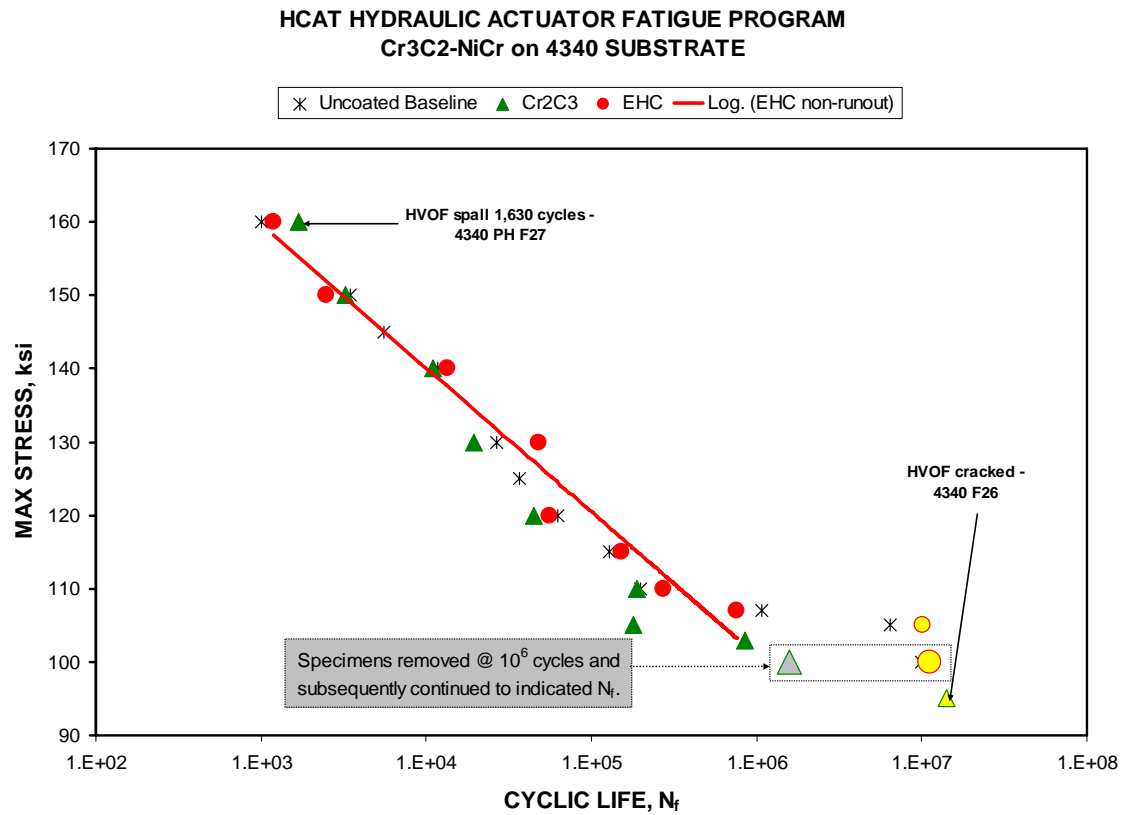
**HVOF Cr<sub>3</sub>C<sub>2</sub>/NiCr :** The fatigue data are shown in Figure 3-8. The HVOF curve is essentially identical to that for EHC, with one point somewhat low. Cracking of the HVOF coating was observed at runout at the lowest load, while spalling occurred in the highest stress region prior to failure at the highest load (Figure 3-9).

**Figure 3-8. Fatigue curves – 4340 steel, HVOF Cr<sub>3</sub>C<sub>2</sub>/NiCr vs EHC, room temperature, R=-1.**

**HVOF Cr<sub>3</sub>C<sub>2</sub>/NiCr:** Specimens coated with HVOF Cr<sub>3</sub>C<sub>2</sub>/NiCr had fatigue equivalent to EHC coated specimens (Figure 3-8). However, it is possible that the fatigue limit was somewhat lower for the HVOF coated specimens (95 ksi for HVOF versus 105 ksi for EHC). Establishing the fatigue limit accurately would require a significant number of additional high cycle tests.

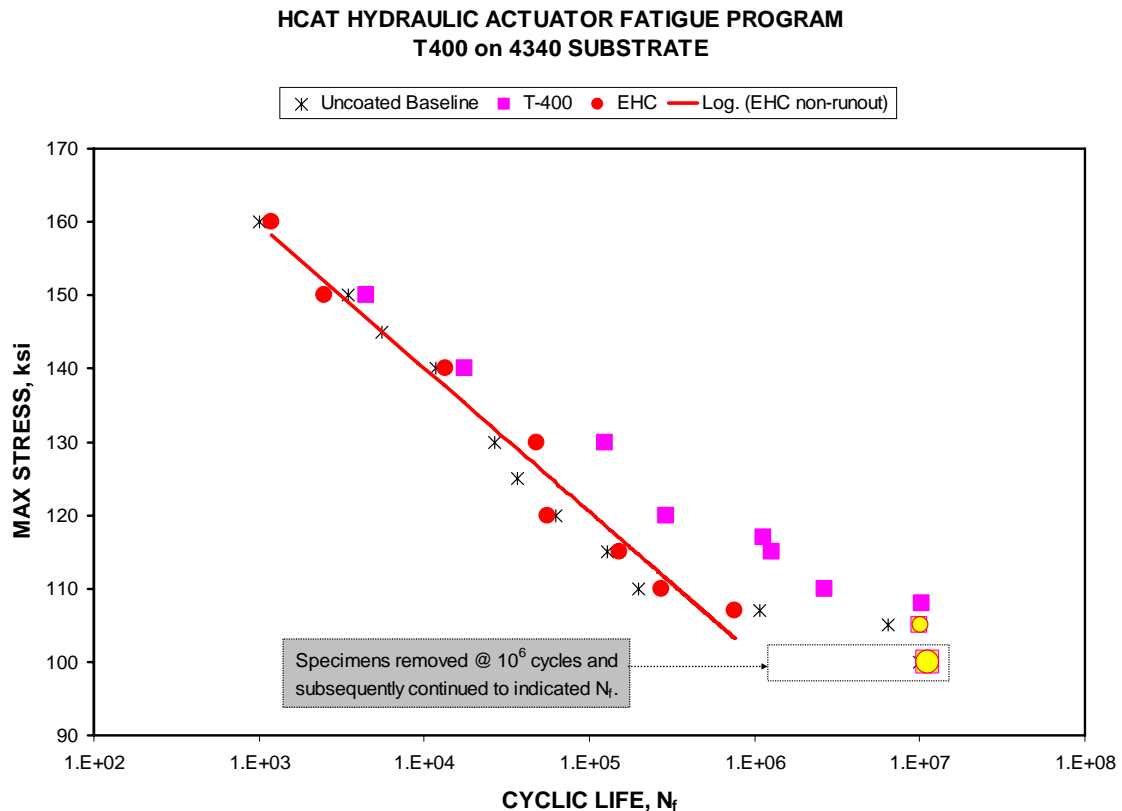
**HVOF Tribaloy 400:** The fatigue data are shown in Figure 3-10. The HVOF data are above those for EHC, especially at high cycles. No cracking or spalling was reported.

**Figure 3-10. Fatigue curves - 4340 steel, HVOF Tribaloy 400 vs EHC, room temperature,  $R=-1$ .**

**Tribaloy 400:** Specimens coated with HVOF T400 showed somewhat better fatigue than those coated with EHC, and even higher than uncoated material, especially at high cycles (Figure 3-10). This is probably a result of the compressive stress in the coating. The fatigue limit appeared to be approximately 105 ksi – essentially equivalent to hard chrome. There was no sign of cracking or spalling of the HVOF T400.

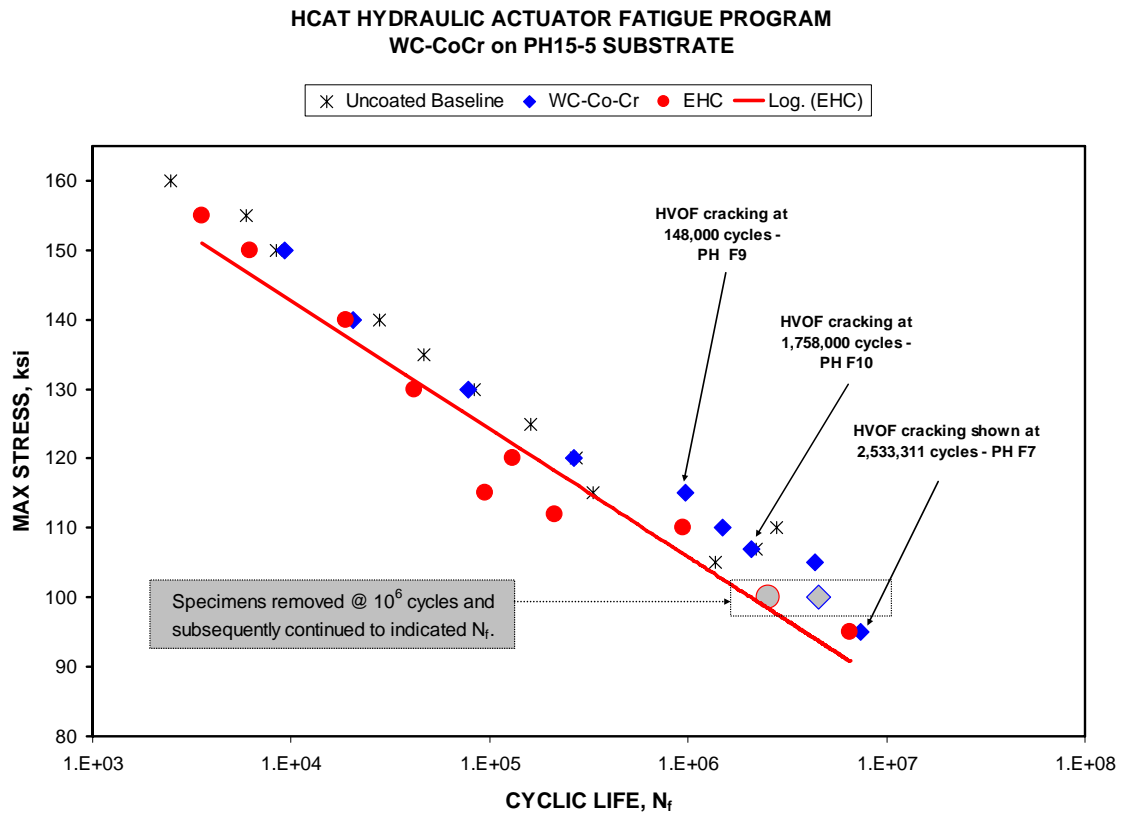
**HVOF WC/CoCr:** The fatigue data are shown in Figure 3-11. The HVOF curve is slightly above that for EHC. Cracking of the coating was observed above 1,000,000 cycles, but no spalling (see Figure 3-12).

**Figure 3-11. Fatigue curves – PH15-5, WC/CoCr vs EHC, room temperature,  $R=-1$ . (Note: 100 ksi stress is equivalent to 0.35% strain.)**

**EHC:** EHC coating caused a small fatigue debit (Figure 3-11).

**HVOF WC/CoCr:** The fatigue curve for HVOF WC/CoCr was essentially equivalent to the uncoated material (Figure 3-11). Above about 1,000,000 cycles the coatings exhibited cracking that appeared to become somewhat more obvious at higher cycles (Figure 3-12). However, there was no evidence of spalling.

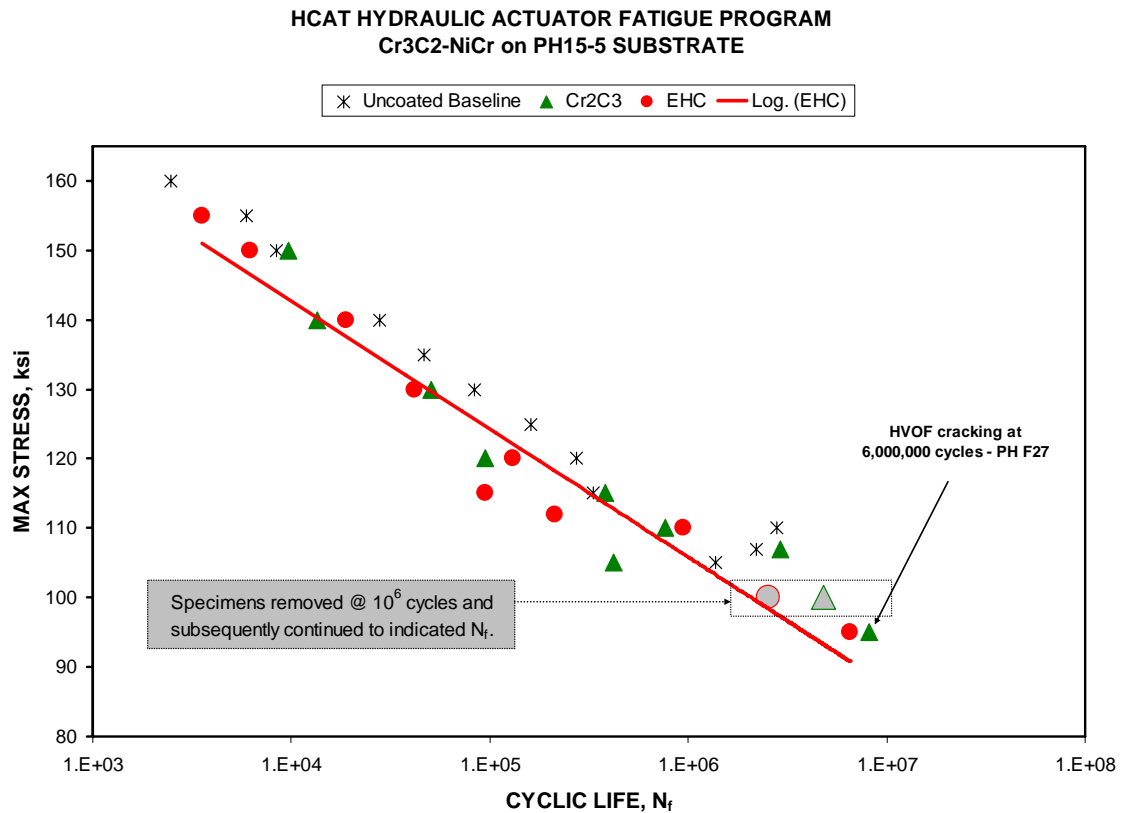
**HVOF  $\text{Cr}_3\text{C}_2/\text{NiCr}$  :** The fatigue data are shown in Figure 3-13. The HVOF curve is essentially identical to that for EHC. Cracking was observed at approximately 6,000,000 cycles (Figure 3-14).

**Figure 3-13. Fatigue curves – PH15-5, Cr<sub>3</sub>C<sub>2</sub>/NiCr vs EHC, room temperature, R=-1.**

**HVOF Cr<sub>3</sub>C<sub>2</sub>/NiCr:** The fatigue curve for HVOF Cr<sub>3</sub>C<sub>2</sub>/NiCr coated specimens was essentially equivalent to that of EHC coated materials (Figure 3-13). Cracking of the coating was observed at the highest cycles (Figure 3-14).

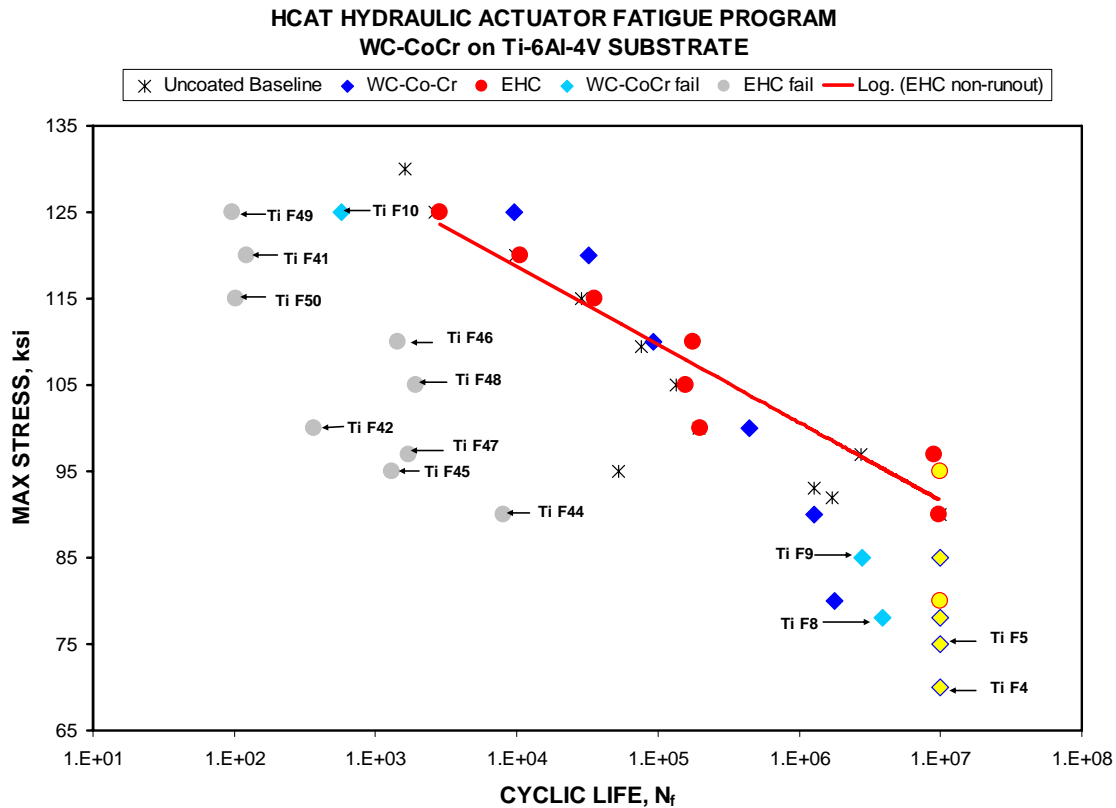
**EHC:** The fatigue data are shown in detail in Figure 3-16, which shows both coating failure and specimen failure loads. Pictures of a number of the specimens are shown in Figure 3-17, chosen to illustrate typical coating failures. Note that the EHC coating spalled well before failure for most specimens.

**HVOF WC/CoCr:** The fatigue data are shown in Figure 3-16. The HVOF curve is essentially similar to or above that for EHC below  $10^6$  cycles, but drops well below it above this load. Pictures of specimens showing cracking or spalling are provided in Figure 3-18.

**Figure 3-16. Fatigue curves – Ti-6Al 4V, WC/CoCr vs EHC, room temperature, R=-1. Light colored points show when spalling occurred for EHC (circles) and WC/CoCr (diamonds). (Note: 100 ksi is equivalent to 0.63% strain.)**

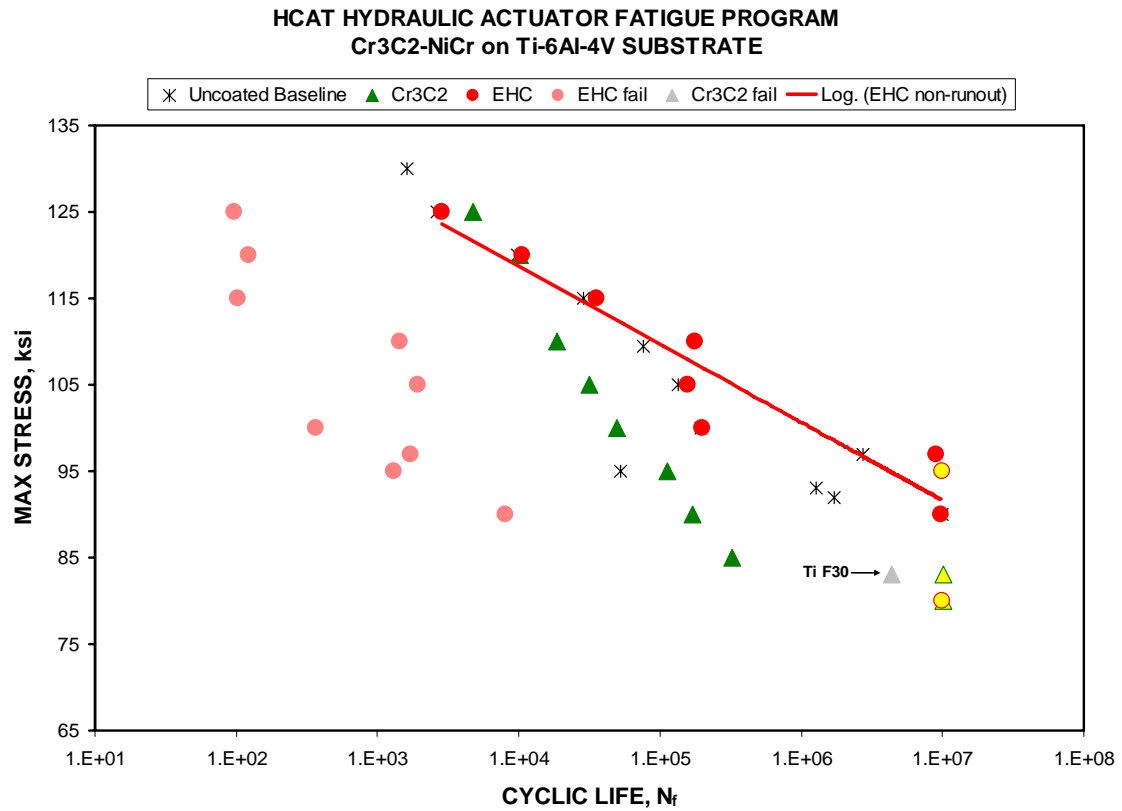
**HVOF  $\text{Cr}_3\text{C}_2/\text{NiCr}$ :** The fatigue data are shown in Figure 3-19. The HVOF curve is well below that for EHC, diverging at higher cycles. The HVOF specimen that showed cracking is shown in Figure 3-20.

**Figure 3-19. Fatigue curves – Ti-6Al 4V,  $Cr_3C_2/NiCr$  vs EHC, room temperature,  $R=-1$ .**

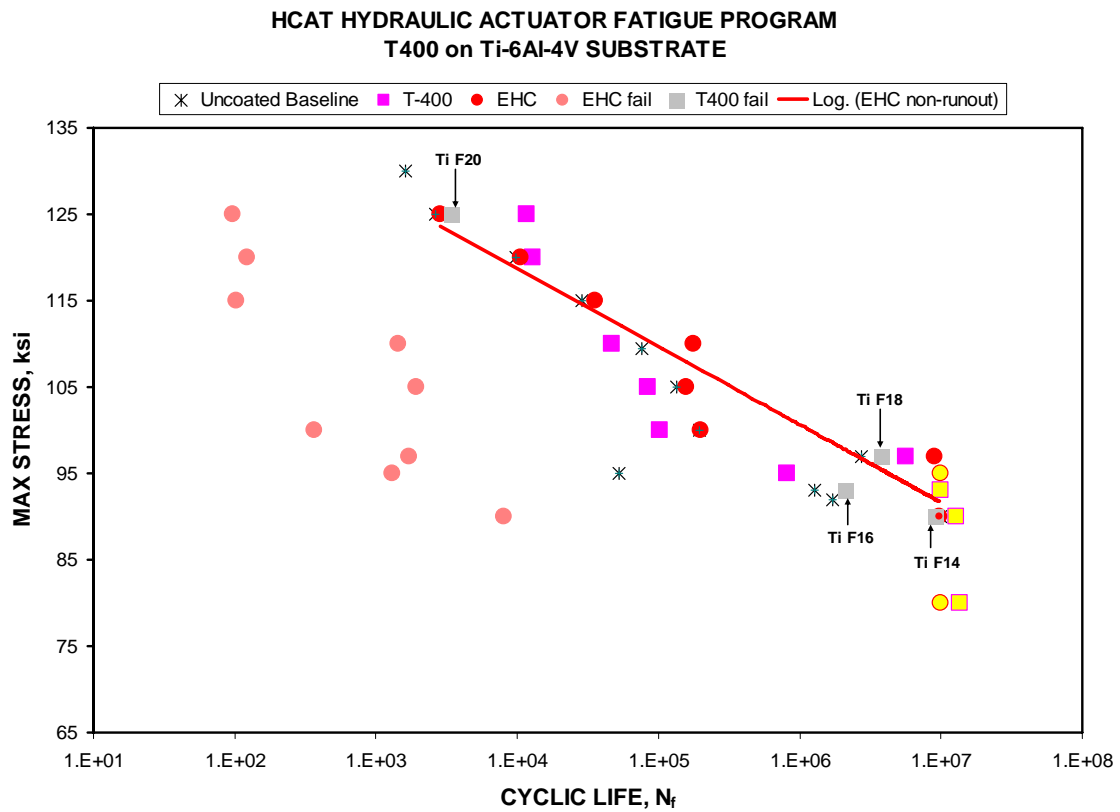
**HVOF Tribaloy 400:** The fatigue data are shown in Figure 3-21. The HVOF curve is essentially identical to that for EHC. The HVOF specimens showing cracking and spalling are shown in Figure 3-22.

**Figure 3-21. Fatigue curves – Ti-6Al 4V, Tribaloy 400 vs EHC, room temperature, R=-1.**

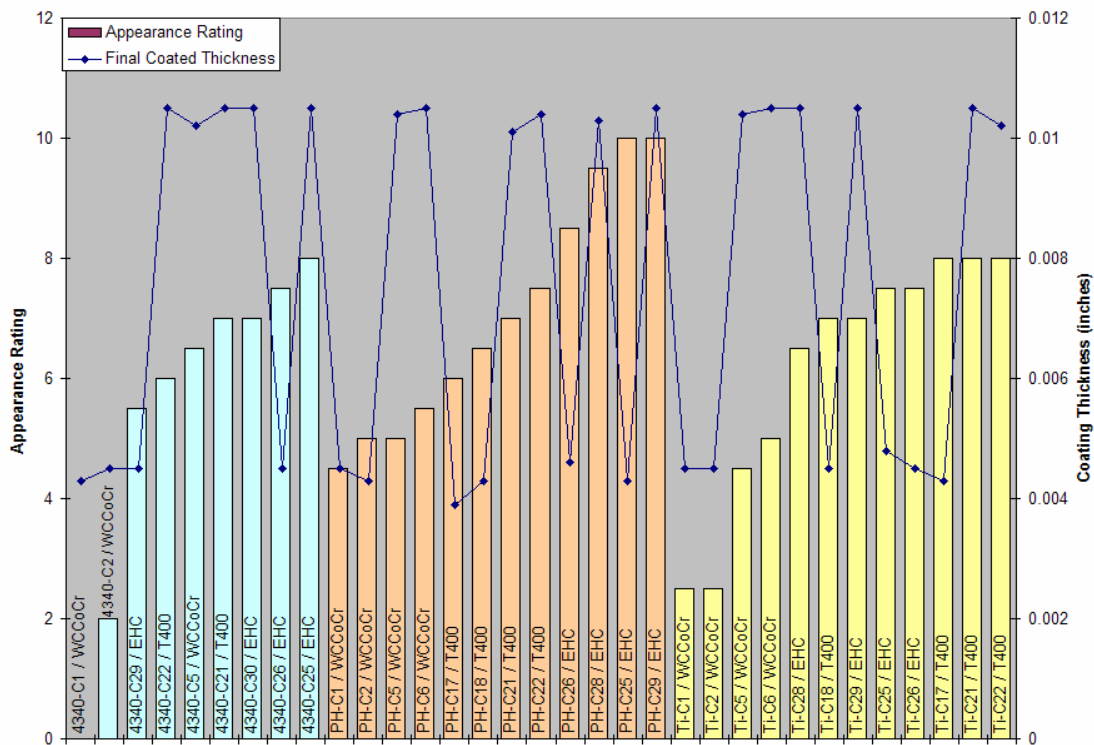
The appearance ratings for the panels after 1000 hours of salt fog exposure are presented in Figure 3-26. The data is

grouped by substrate material and also indicates the coating thickness for each panel. The corrosion performance of the EHC-coated panels for all three substrate materials was superior to that of the two HVOF coatings. The average rating for the EHC-coated PH15-5 panels was 9.5, followed by the EHC-coated Ti-6Al-4V with an average rating of 7.1 and the EHC-coated 4340 with an average rating of 7.0. The performance of the T400 coatings on all three substrates was almost comparable to that of the EHC coatings, with an average rating of 7.8 on Ti-6Al-4V, 6.8 on PH15-5 and 6.5 on 4340. The WC/CoCr coatings appeared to provide somewhat less protection, with an average 5.0 rating on PH15-5, 3.6 on Ti-6Al-4V and 2.8 on 4340.

**Figure 3-26 Appearance ratings and coating thicknesses for EHC- and HVOF-coated panels, grouped by substrate material, and shown from worst to best corrosion performance within each substrate group.**

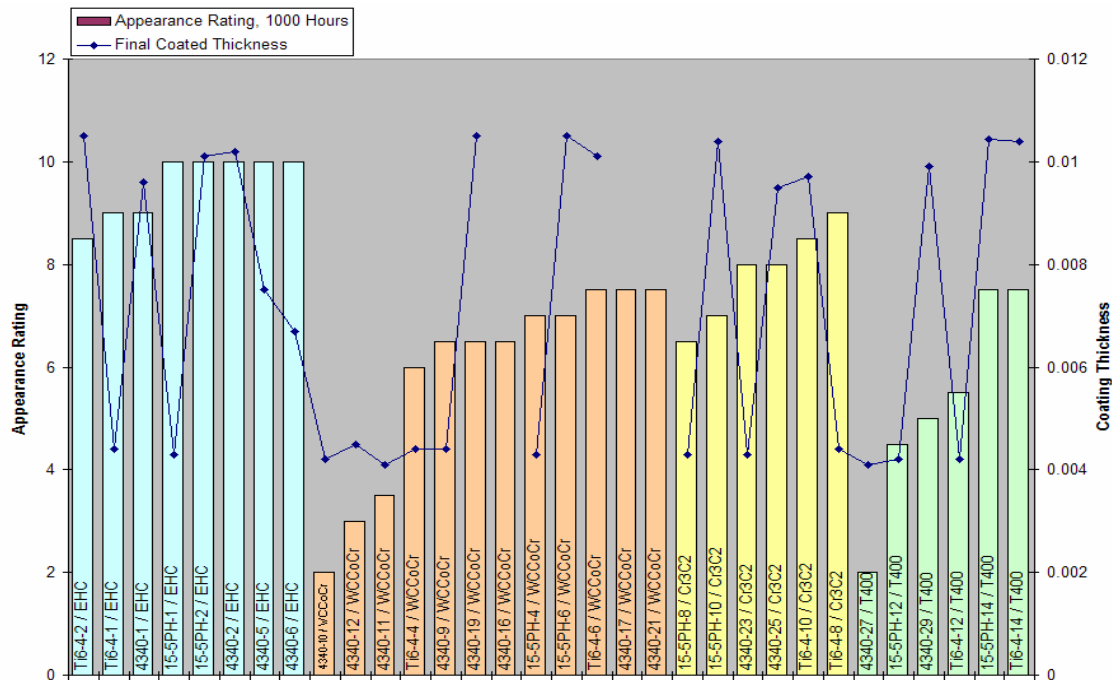
**Figure 3-28 Appearance ratings and coating thicknesses for EHC- and HVOF-coated rods, grouped by substrate material, and shown from worst to best corrosion performance within each substrate group.**

Figure 3-28 presents the appearance ratings and coating thicknesses for the rods grouped by substrate material and Figure 3-29 presents the appearance ratings and coating thicknesses for the rods grouped by coating. The corrosion performance of the EHC-

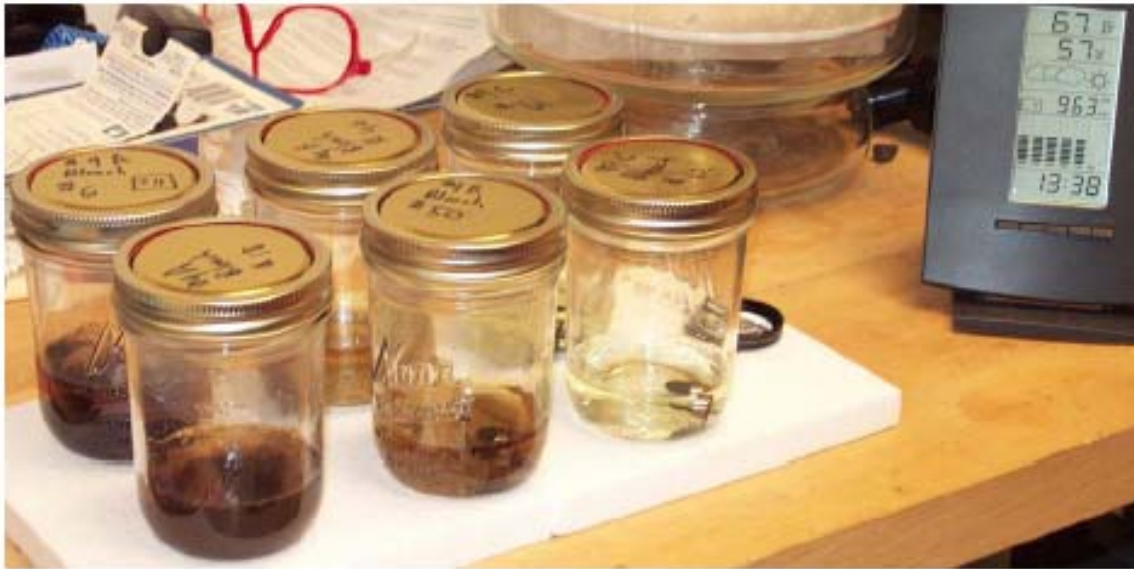
**Figure 3-32 Six specimens immersed in bleach solution at 20° C**

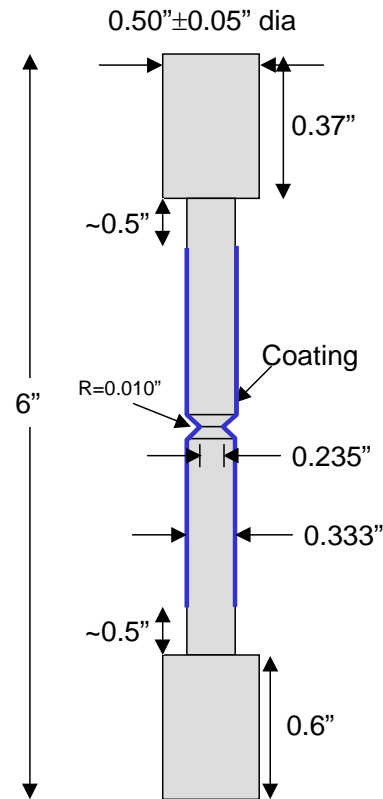
**Figure 3-33 Type 1a.2 hydrogen embrittlement specimen showing the area on which the HVOF coating was applied.**

In previous HVOF spraying of these types of specimens, the overspray material, which would normally bounce back off the surface, tended to become trapped in the notch, producing a thicker and more porous coating. In order to minimize this entrapment for these specimens, a strong air stream was directed into the notch and the HVOF coatings were applied with the gun at an angle of 30° to the normal. During coating application the specimens were rotated while the gun was traversed, angling the gun at +30° from the normal when traveling in one direction and -30° from the normal when traveling in the other direction. During coating application, air cooling was used to ensure the surface of the specimen did not exceed 375°F. Figure 3-33 shows the area on the specimens that was coated.

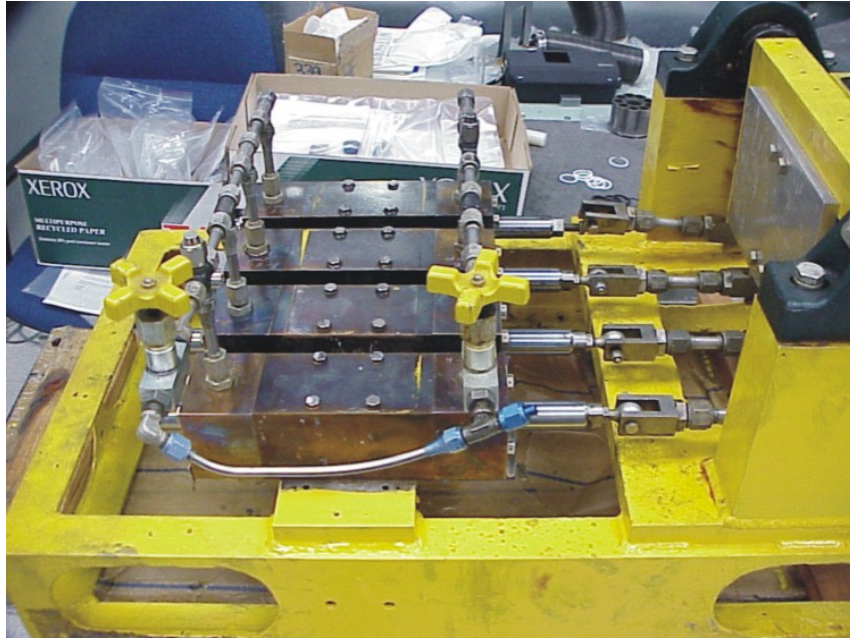
**Figure 4-2 Test Apparatus Consisting of Four Rods Passing Through Blocks Containing Seals**

Figure 4-1 is a photograph of the master hydraulic piston, showing it passing through the wall of the environmental chamber and also showing the pressure gage measuring the instantaneous fluid pressure. Figure 4-2 and Figure 4-3 show the apparatus consisting of

the four test rods and the blocks that contain the seals. This entire apparatus fits inside the environmental chamber.

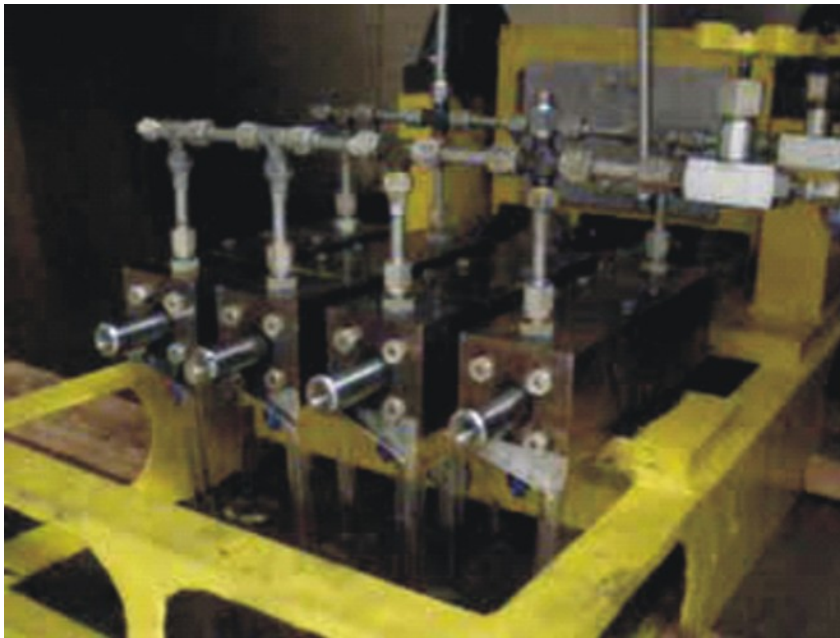
**Figure 4-3 Photograph of Rod/seal Test Apparatus**

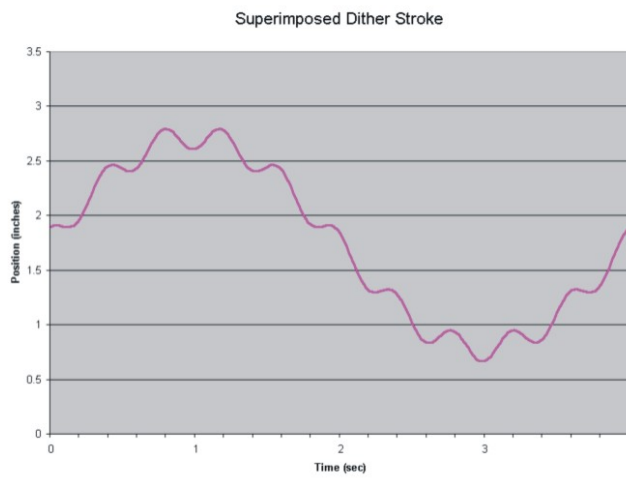
**Figure 4-8 Superimposed Dither Stroke Profile**

A specific temperature and cycling spectrum was established for the test which was run for 8 hours per day for 16 days to achieve a total of 1,040,000 cycles. The test specimens and fixture were maintained at 0 °F between each day of testing to evaluate static leakage at start-up. There was a static pressure of 3000 psi applied to both ends of each test block. Table 4-5 presents the cyclic test drive ram stroke conditions and Table 4-6 indicates the cyclic test cycle definitions. Table 4-7 gives the temperature cyclic profile. Figure 4-7, Figure 4-8 and Figure 4-9 show the profiles for full stroke, super-imposed dither stroke and dither stroke, respectively.

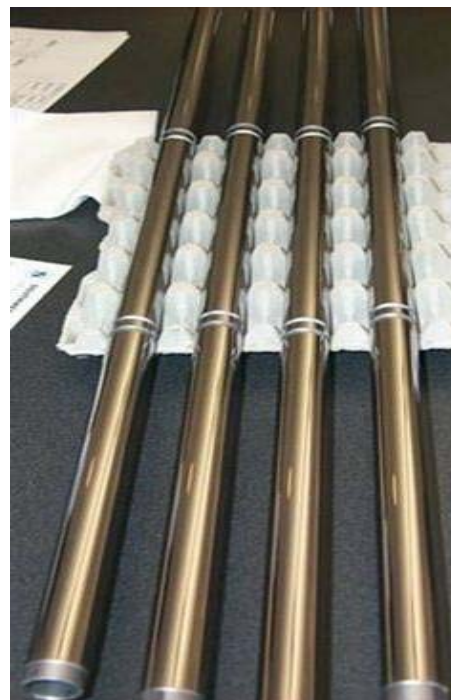
**Figure 5-2 C130 Rudder Booster Actuator Piston Rods Coated with HVOF WC/CoCr**

Figure 5-2 is a photograph of the piston rods subsequent to application and grinding of the HVOF WC/CoCr coatings (three for testing and one spare). Coating application was performed by Southwest Aeroservice in May 2004, the assembly of the actuators was performed by OO-ALC in May 2004 and the testing was performed by Smiths Aerospace in Duarte, California in July 2004. They performed an endurance test for 1,000,000 cycles in a temperature range of -65°F to +160°F. Figure 5-3 shows an assembled rudder boost pack.

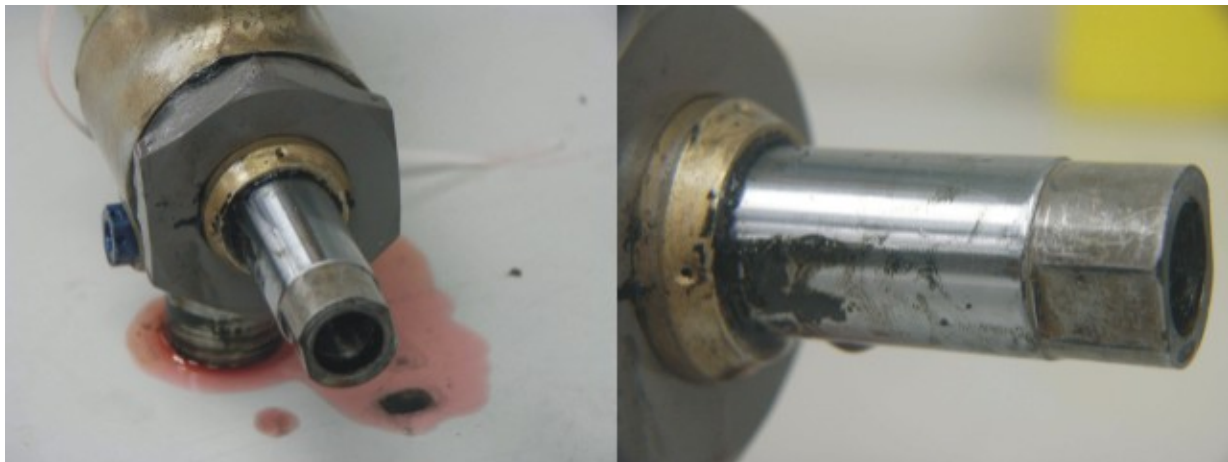
**Figure 5-4 Portion of EHC-plated Piston Rod from C130 Rudder Booster Actuator that Failed Endurance Test.**

Three WC/CoCr-coated piston rods completed the 1,000,000 cycles and three sets of seals passed the endurance testing, an elastomeric T-seal, an Enercap II from Greene-Tweed and a Plus Seal II from Shamban. A piston rod with standard EHC plating failed after 415,145 cycles. Figure 5-4 is a photograph of a portion of the failed rod. No data was provided on the cause of this failure.

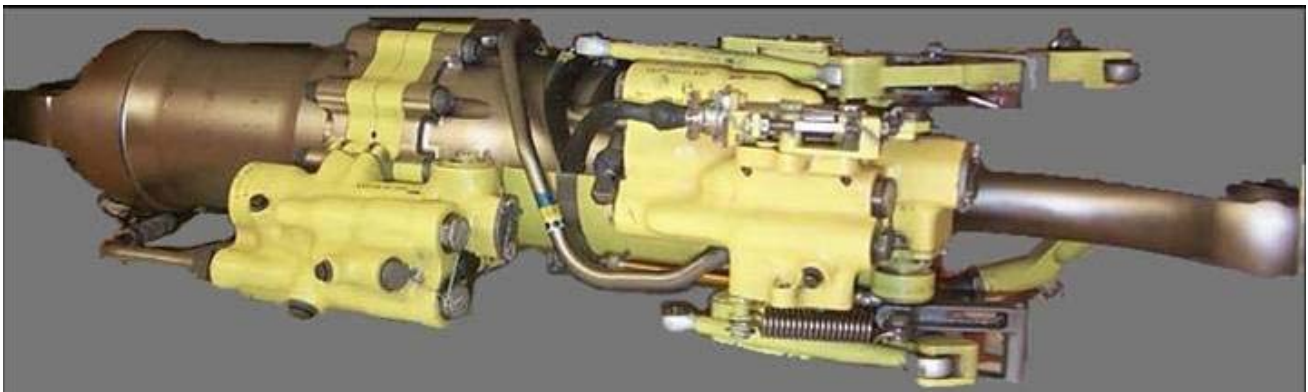
**Figure 5-5 Photograph of the B-1 Horizontal Stabilizer Actuator.**

Figure 5-5 is a photograph of the B-1 horizontal stabilizer actuator which drives the horizontal stabilizer surfaces for pitch and roll control. Its location on the aircraft is indicated in Figure 5-6. The forward piston required redesign to eliminate fatigue failures (a problem not associated with the EHC plating on the piston rod). The qualification of the new design required fatigue and endurance tests, which provided an opportunity to qualify HVOF WC/CoCr as an alternative coating on both the forward and aft piston rods.

For this actuator the operating pressure is 4000 psi and the stroke is 6.843 inches. The forward piston OD is 2.4 inches, the forward head OD is 4.8 inches, the aft piston OD is 3.1 inches and the aft head OD is 5.2 inches. The piston rod material is HP9-4-30.

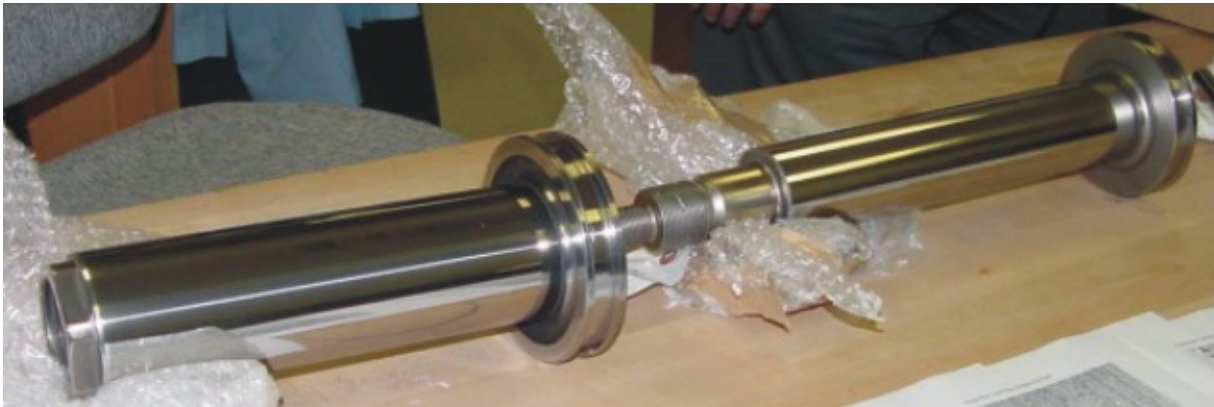
**Figure 5-7 Photograph of Forward and Aft Pistons from the B-1 Horizontal Stabilizer Actuator Following Application of HVOF WC/CoCr Coating**

For the delta qualification test, the forward piston was coated with WC/CoCr by Southwest United Industries and the aft piston was coated with WC/CoCr by Plasma Technologies Inc. Figure 5-7 is a photograph of the two pistons subsequent to coating application and grinding.

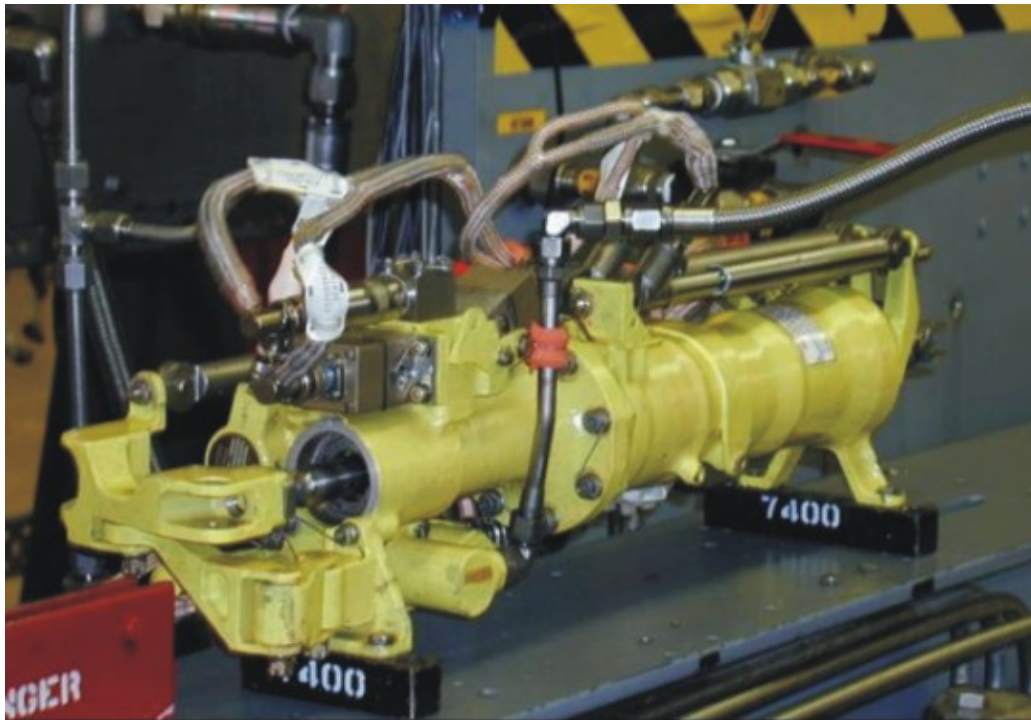
**Figure 5-8 B-1 Pitch/roll SCAS**

This component, shown in Figure 5-8, provides pitch and roll input to mixers and on to horizontal stabilizer surfaces for added stability and for autoflight. The stroke is 3.5 inches and the operating pressure is 4000 psi. The primary piston OD is 0.7 inches, the secondary piston OD is 0.5 inches, the head OD is 1.2 inches and the groove OD is 0.9 inches. The piston rod material is HP9-4-30.

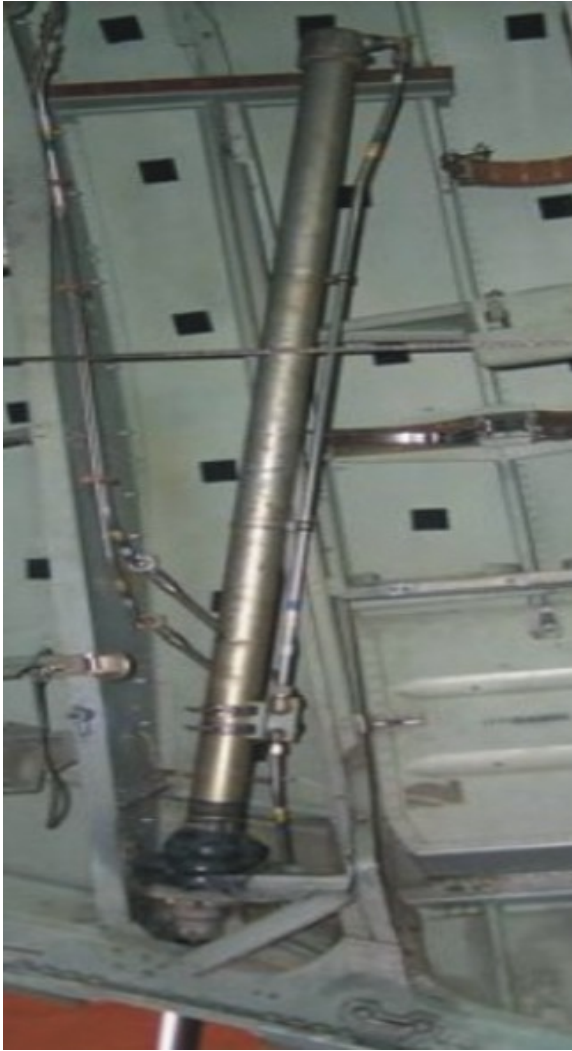
**Figure 5-10 C-130 Ramp Actuator  
Installed on Aircraft**

This component, shown installed on the aircraft in Figure 5-10 and removed for disassembly in Figure 5-11, is used to operate the C-130 ramp door. It has a stroke of 64.998 inches, a retracted/extended length of 74.6/139.6 inches and an operating pressure of 3000 psi. The piston OD is 1.8 inches and the head OD is 2.3 inches. The piston rod

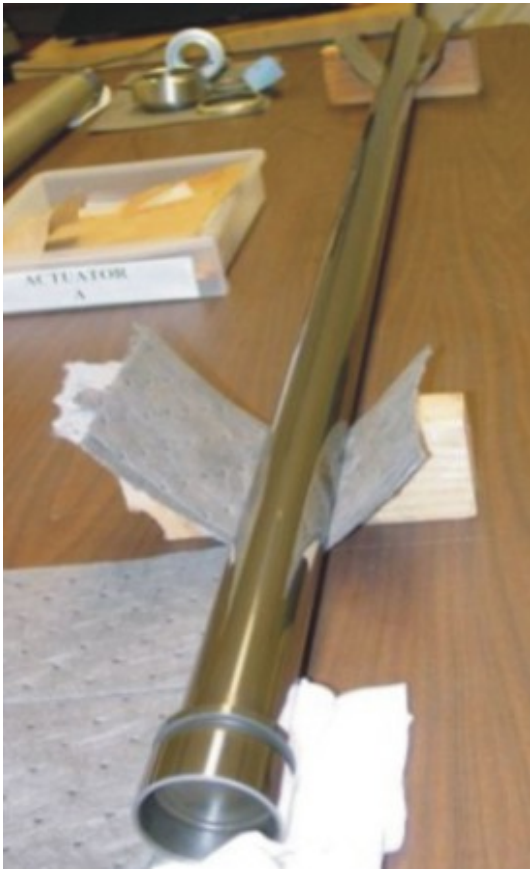
**Figure 5-12 C-130 Ramp Actuator Piston After Application of HVOF WC/CoCr Coating**

Two piston rods were coated with HVOF WC/CoCr by Southwest United Industries. Figure 5-12 is a photograph of one piston rod subsequent to application of the coating and grinding. Testing was performed by ARINC and OC-ALC/ENFLL in the OC-ALC Engineering Laboratory. It consisted of a 20,000 cycle endurance test and a temperature test in which each actuator was subjected to a cold soak at -65°F and then cycled 5 times while still at that temperature. Figure 5-13 is a photograph of the test fixture at OC-ALC.

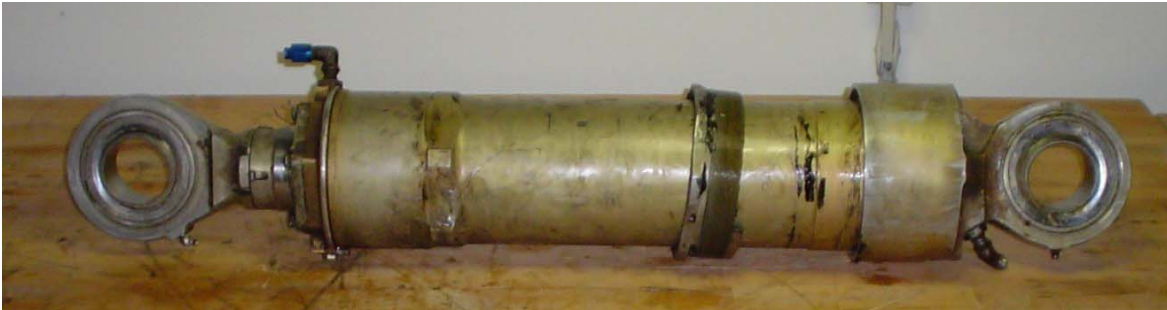
**Figure 5-14 C/KC-135 Main Landing Gear Actuator**

This component, shown in Figure 5-14, is used to extend and retract the C/KC-135 main landing gear. It has a stroke of 13.78 inches, a retract/extended length of 30.84/44.62 inches, and an operating pressure of 3000 psi. The piston OD is 2.995 inches and the head OD is 4.8 inches. The piston rod material is 4340 steel. Two piston rods were coated with HVOF WC/CoCr by Southwest United Industries. The testing was performed by ARINC and OC-ALC/ENFLL in the OC-ALC Engineering Laboratory. For endurance testing, each actuator was subjected to 20,000 cycles and for temperature testing each actuator was subjected to a cold soak at -65°F, then cycled 5 times while still at that temperature.

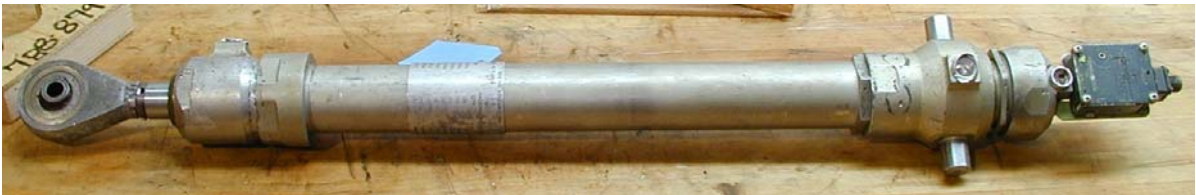
**Figure 5-15 C/KC-135 Main Landing Gear Door Actuator**

This component, shown in Figure 5-15, is used to open and close the main landing gear door on the C/KC-135. It has a stroke of 20.66 inches, a retracted/extended length of 31.00/51.66 inches, and an operating pressure of 3000 psi. The piston OD is 1.3 inches and the head OD is 2.1 inches. The piston rod material is 4140 or 4340 steel.

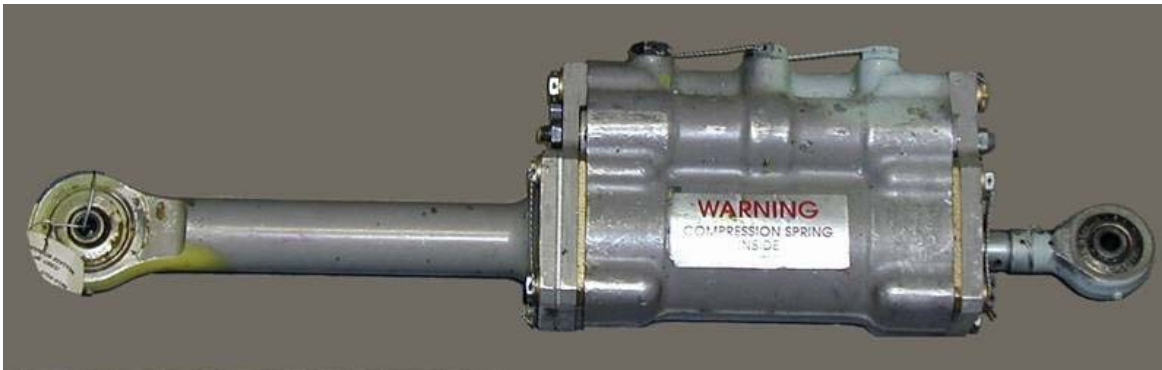
**Figure 5-16 C/KC-135 Aileron Snubber Actuator**

This component, shown in Figure 5-16, is used to dampen the oscillations of the C/KC-135 aileron. It has a stroke of 1.81 inches, a retracted/extended length of 15.595/17.455 inches and an operating pressure of 3000 psi. It has a piston OD of 0.6 inches and the piston rod material is 4340 steel.

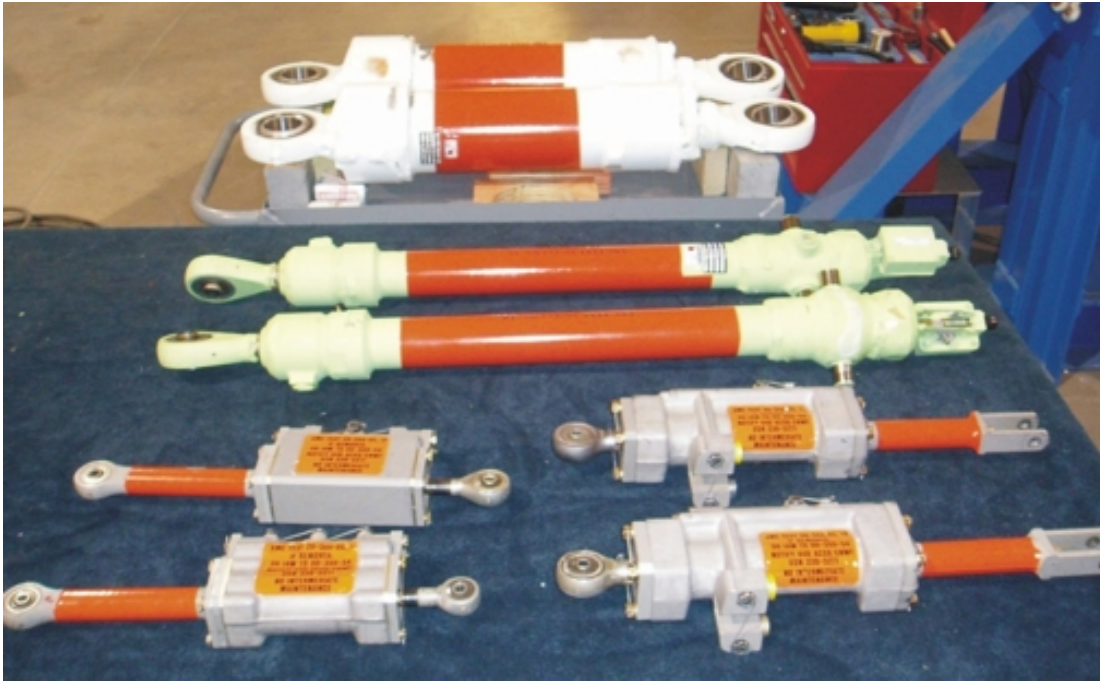
**Figure 5-17 C/KC-135 Actuators Prepared for Service Testing**

The C/KC-135 service test will include the evaluation of two snubbers, two main landing gear actuators, two main landing gear door actuators and two rudder actuators, all containing piston rods coated with HVOF WC/CoCr. Figure 5-17 shows the actuators prepared and ready for installation which is planned to be conducted on aircraft at Grand Forks AFB and MacDill AFB in March 2006.

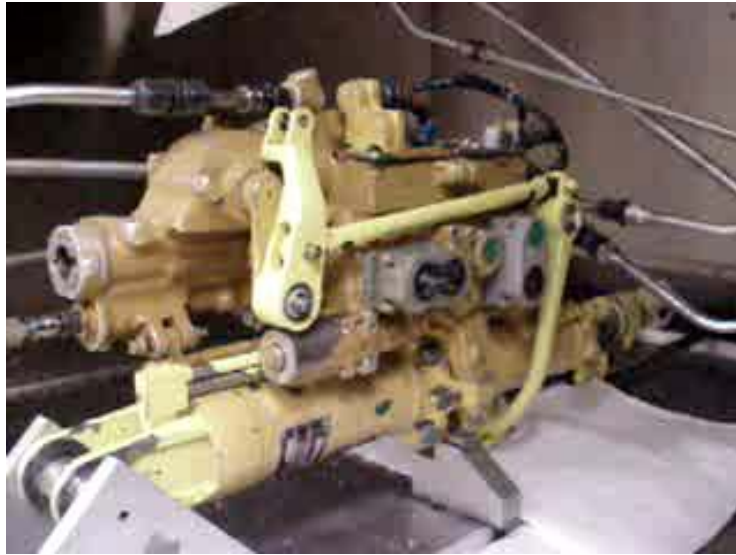
**Figure 5-18 F/A-18 C/D Stabilator Actuator**

There had been a history of significant reliability problems with this actuator, shown in Figure 5-18 and schematically in Figure 5-19, due to external fluid leakage, requiring rework every six months. Based on laboratory testing, the elastomeric seals were replaced with fluorocarbon static seals and PTFE spring-energized dynamic seals. Rebuild kits were developed by seal vendors and endurance testing of the seal kits from three vendors showed excellent performance, with post-test leakage within acceptable limits. All of these tests were performed using standard EHC plating on the piston rods.
